Case Study: Decorative/ Fishing Pond

Washington Department of Fish and Wildlife wanted to provide a fishing area that was safe for children and disabled persons near Chelan Falls on the Columbia River.

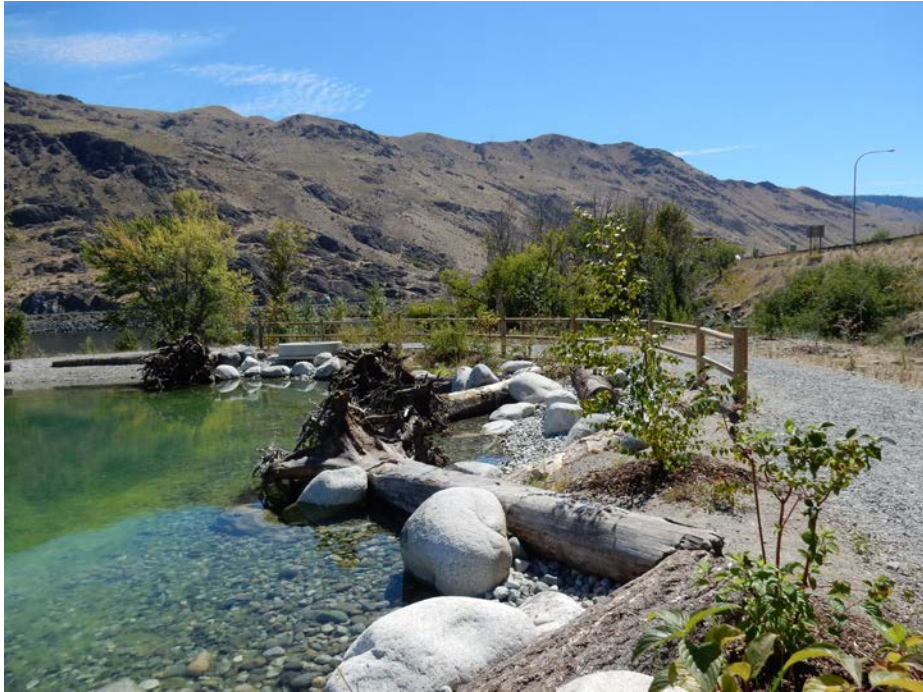
The pond was constructed near the Columbia River with controlled access and a parking area with care being taken to keep the river clean. Water intake and overflow structures were built to get water from the river and let it flow back into the river after being in the pond. The pond was lined to prevent water loss because the native soil was very sandy and rocky. After the lining was complete the pond was landscaped with native plants, waterfalls and large rocks were added to create a natural look. Structures and fish habitat were placed in the pond to provide for the native fish released into the pond. Fishing areas were created that allowed for children and disabled persons to be able to fish in a safe environment.

8 oz. Non-Woven Geotextile above and below the liner as a cushion.
40 mil HDPE Geomembrane Single Sided Textured Liner
